**SANI EFFECT™**  
WATER • MOLD • INDOOR AIR QUALITY

Sani Effect Environmental Inc.

# ASSESSMENT REPORT

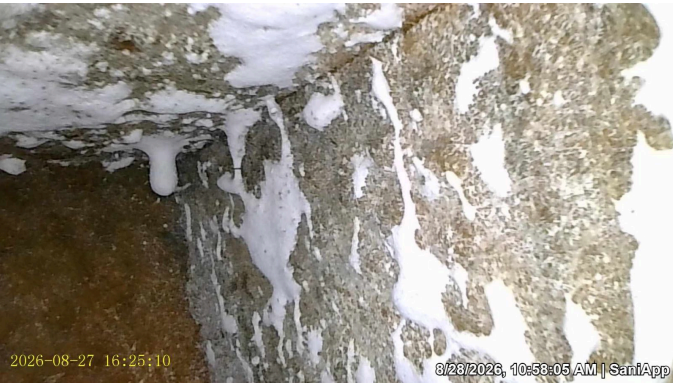
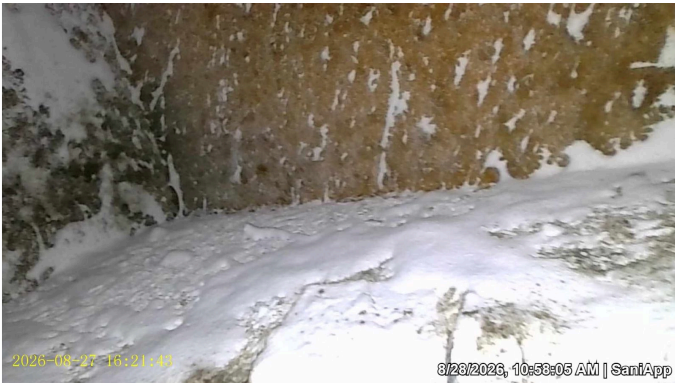
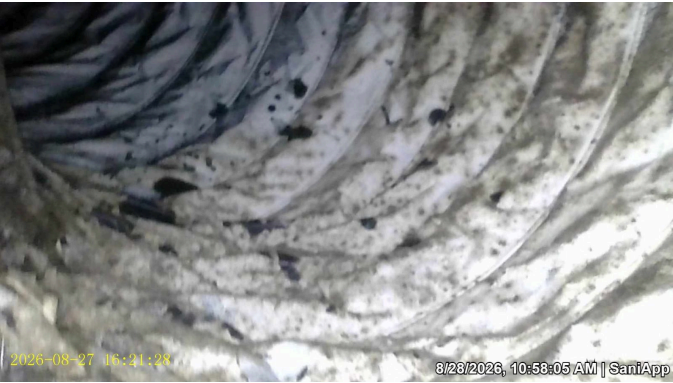
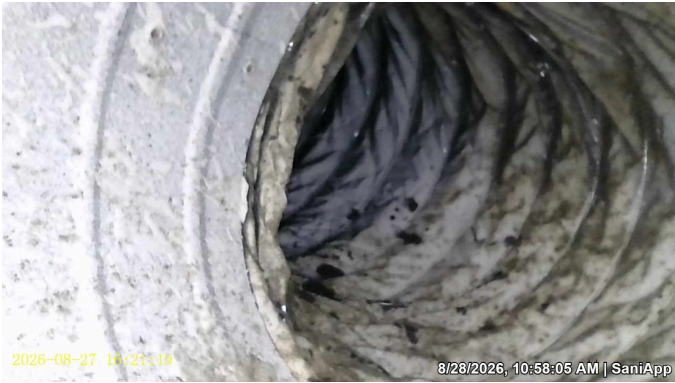
During the inspection utilizing an endoscope camera, we observed the presence of dark spots indicative of microbial growth on the fiberglass surfaces within several ventilation ducts. Additionally, microbial growth was identified extending at least one foot into the flexible ductwork.

- **HVAC System Cleaning:** Perform a comprehensive cleaning of the HVAC units, including the air handler, evaporator coils, supply vents, and return air plenums, utilizing Sani Effect Organic Products. Alternatively, consider replacing the entire flexible duct system, including connection boxes, plenums, and returns.

- **Sealant Application:** Apply specialized sealants (IAQ 8000 or Sentinel 539) to the HVAC components and any porous surfaces that may harbor mold.

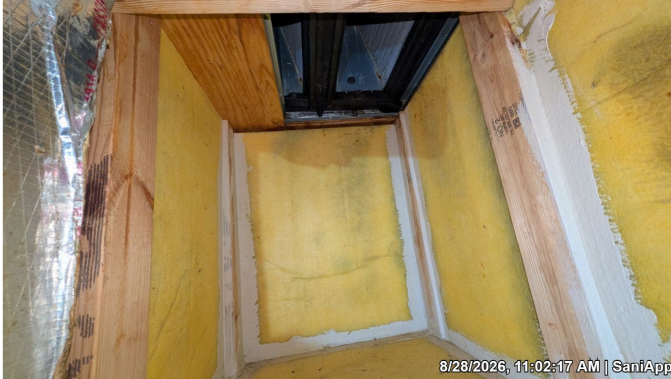
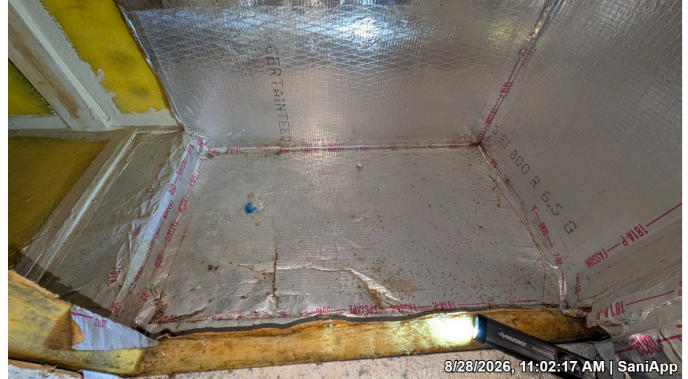
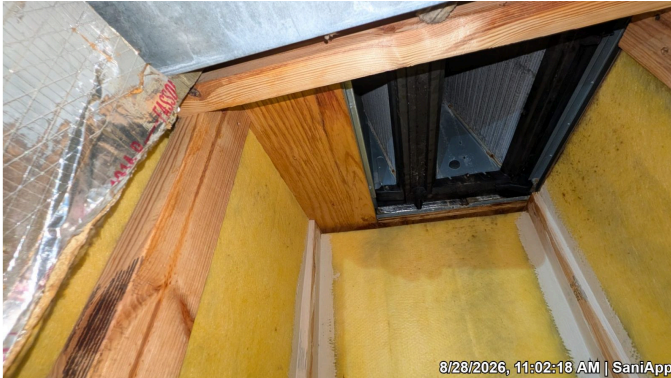
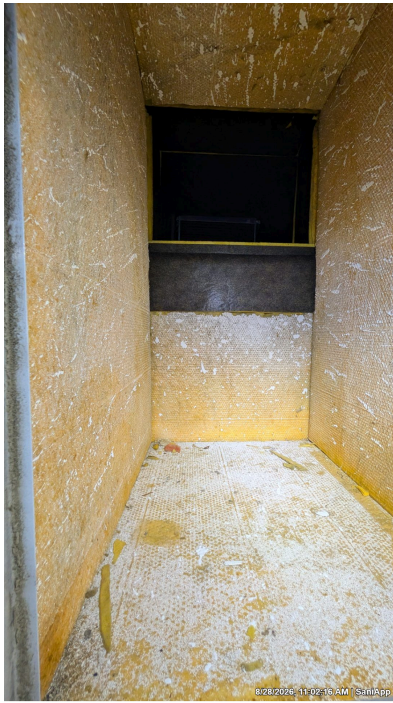
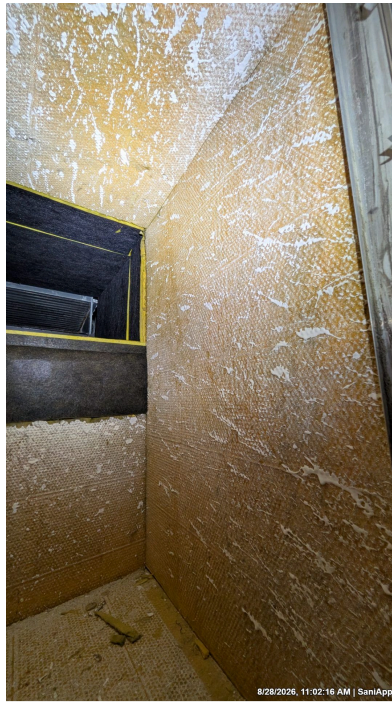
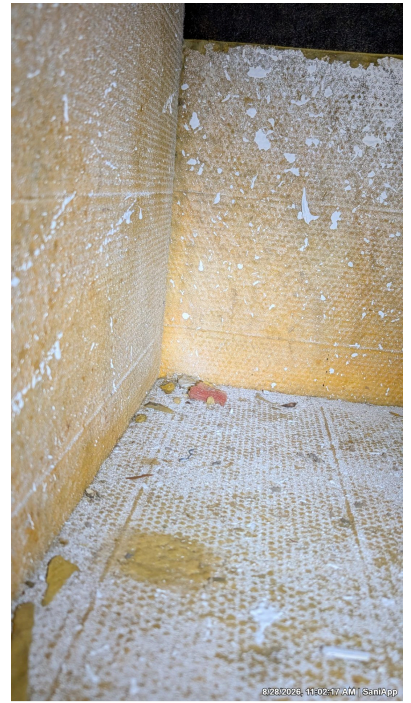
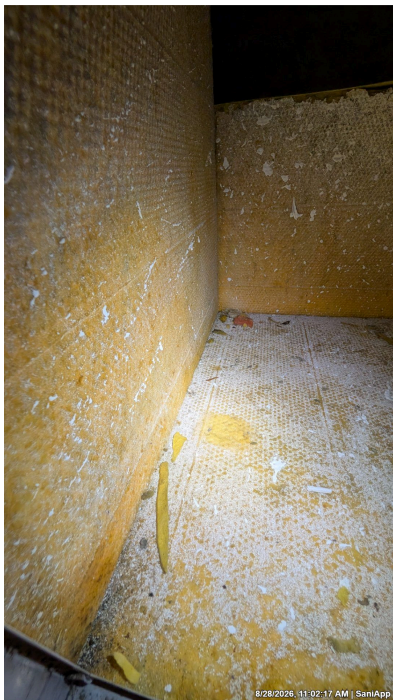
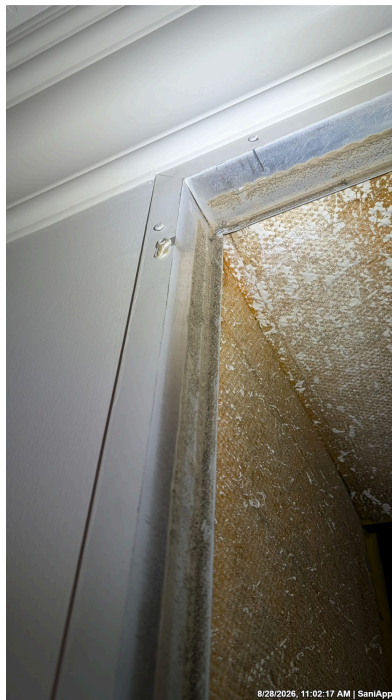
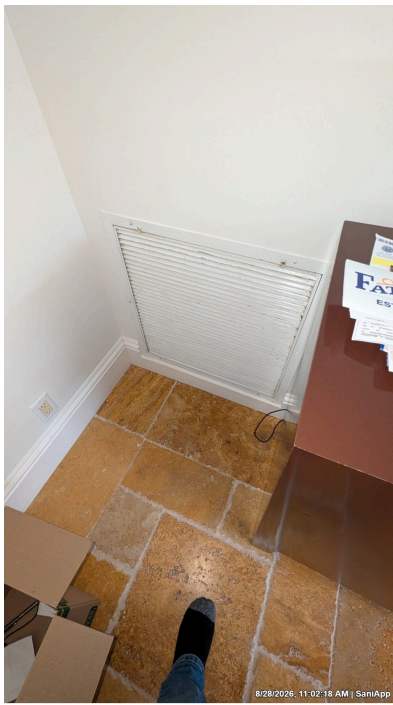
The return vents of the two HVAC units exhibit significant dust accumulation and evidence of microbial growth on the fiberglass surfaces. It is recommended to conduct a thorough cleaning and remediation of these surfaces to eliminate any potential health hazards associated with the presence of contaminants.

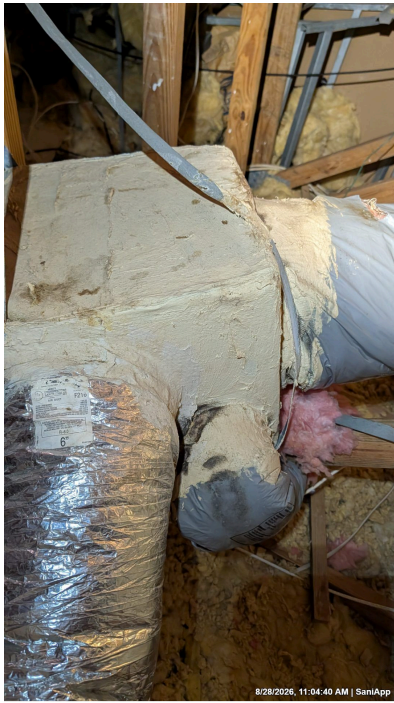
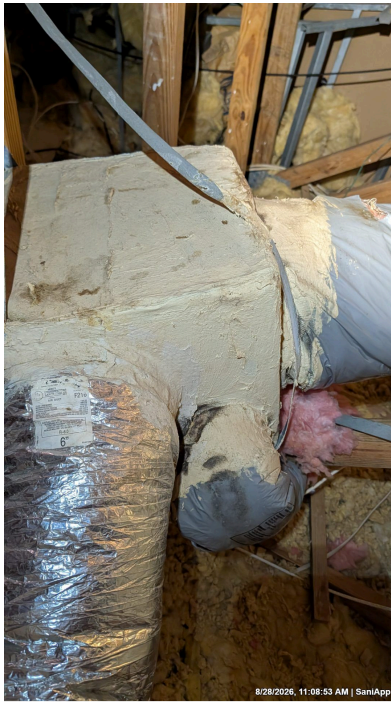
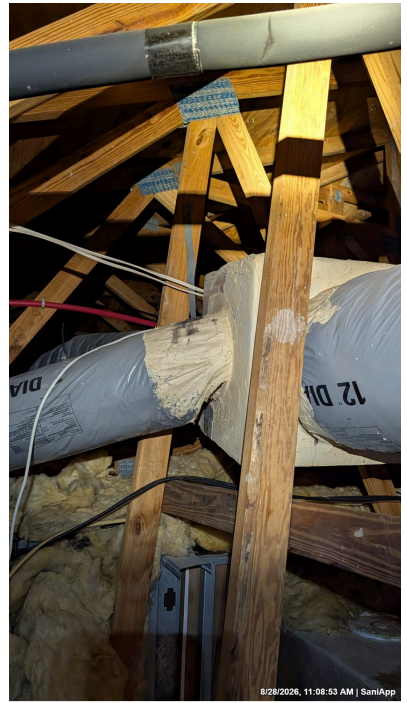
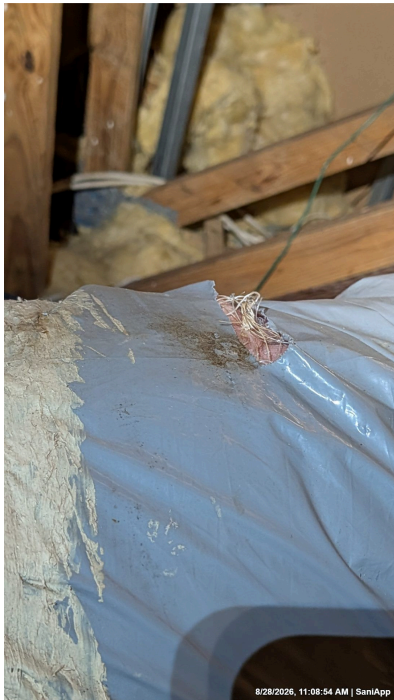
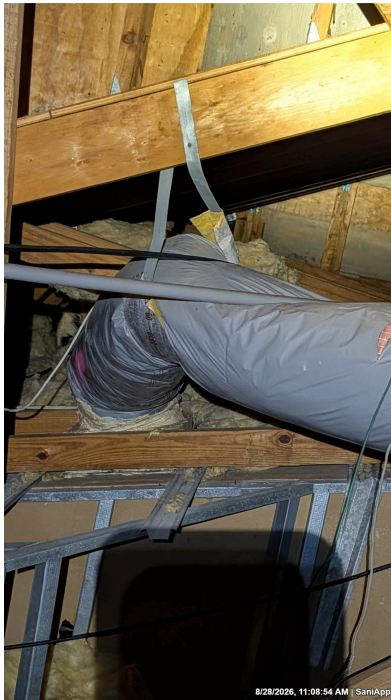
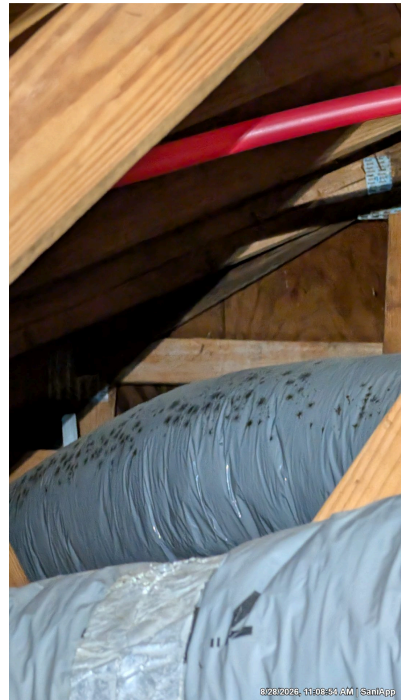
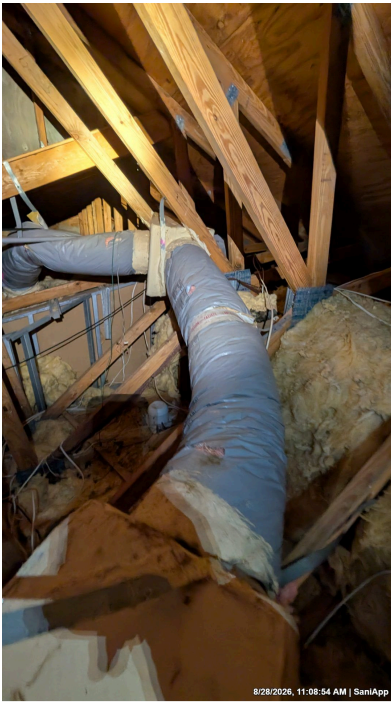
The Plenum box and the Return Box of the HVAC unit located in the attic have been recently replaced; however, the remainder of the duct system is significantly aged. The connection boxes and the existing ductwork exhibit external cracks and signs of microbial growth. This condition is attributed to damage sustained by the insulation surrounding the flexible ducts. Typically, flexible ducts have a lifespan of approximately 12 to 20 years, after which they begin to lose their thermal efficiency. This deterioration leads to air leakage, resulting in the escape of cold air and the subsequent formation of condensation, which fosters the growth of mold on the ducts.

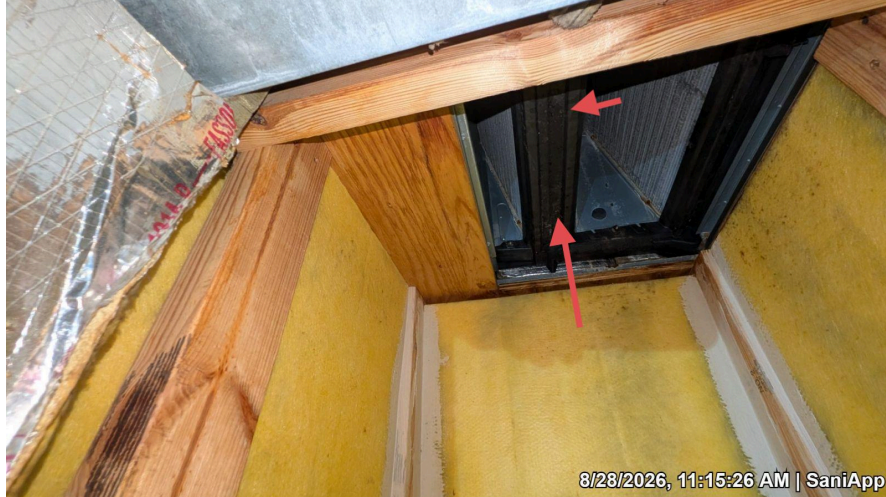
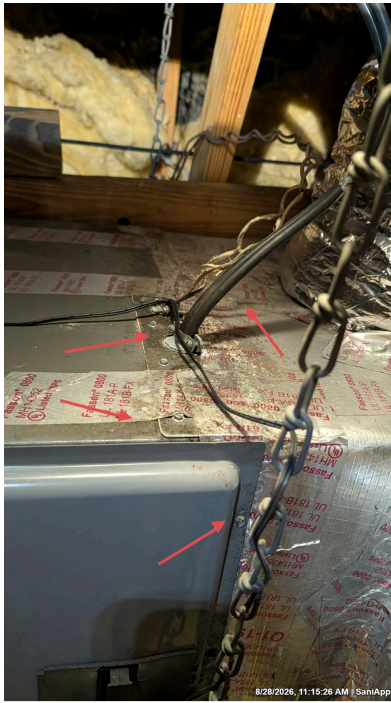
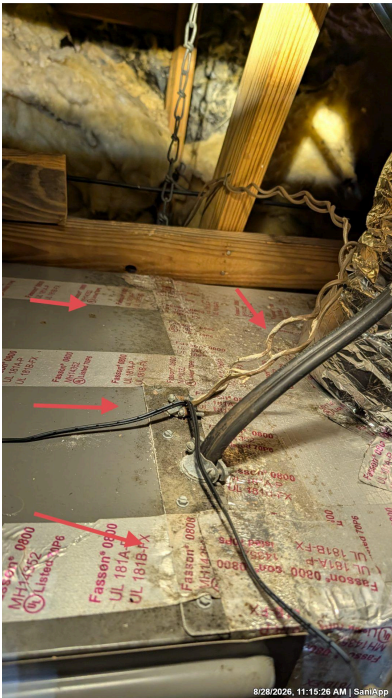
The two HVAC units located in the attic and garage require comprehensive cleaning and sanitation treatment to ensure optimal performance and indoor air quality.

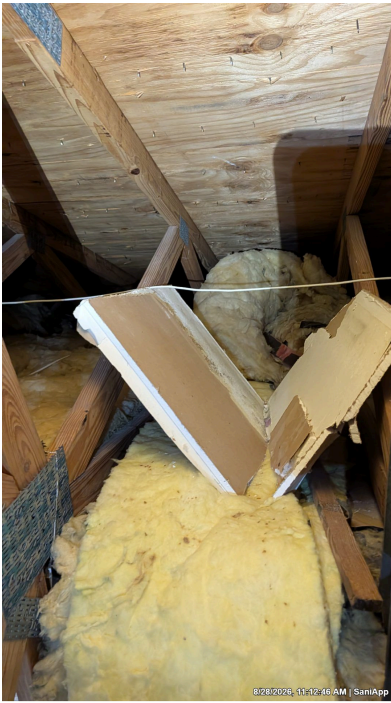
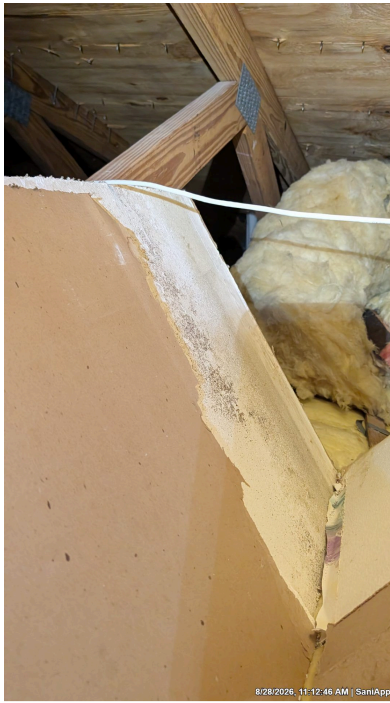
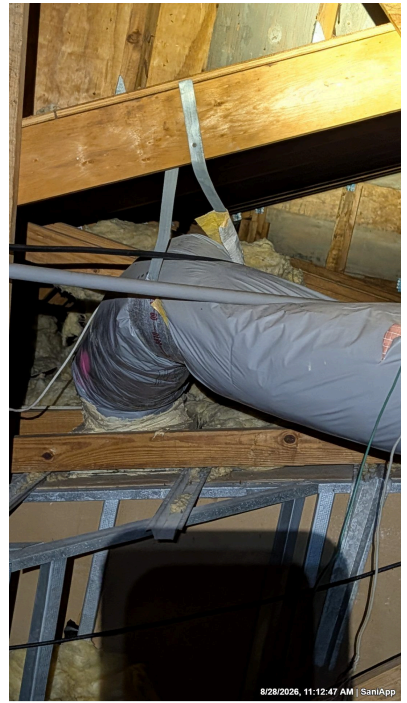
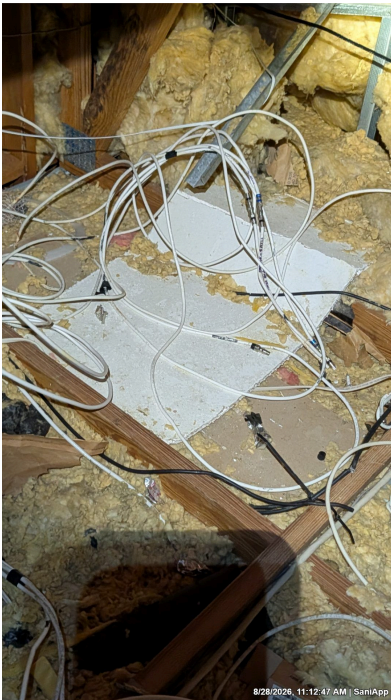
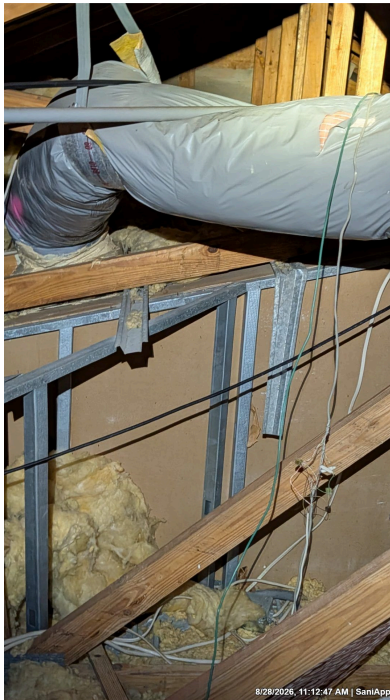
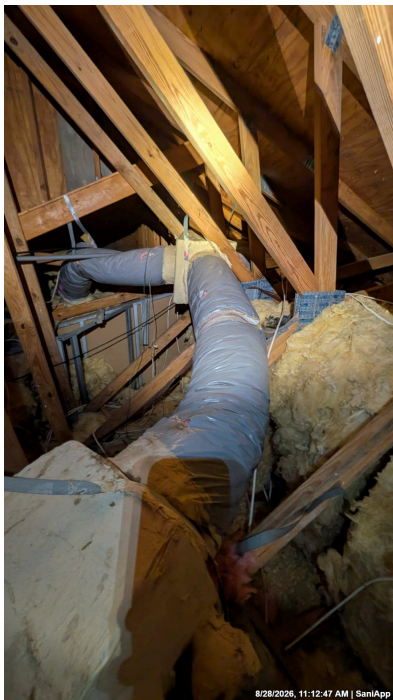
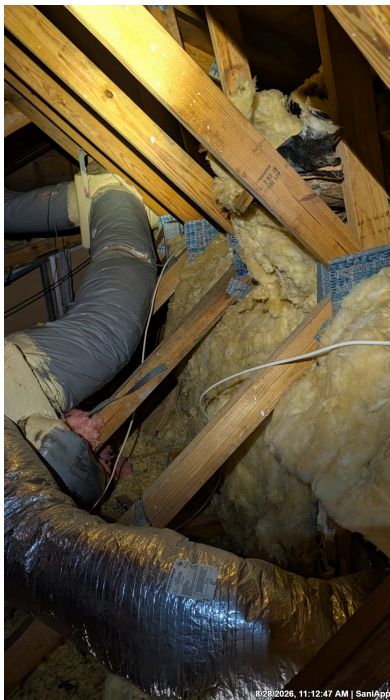
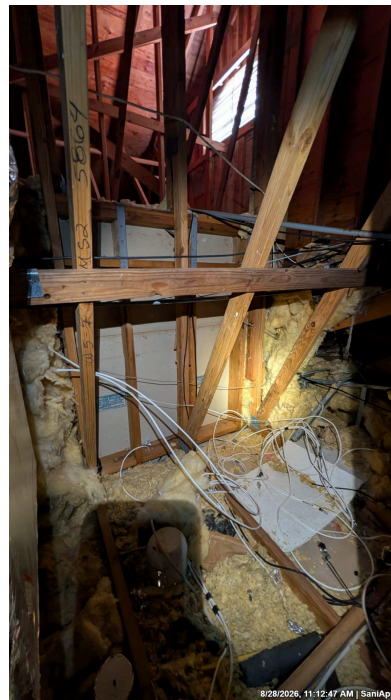
Multiple sections of the attic exhibit a lack of insulation in both vertical and horizontal areas. This deficiency results in the drywall absorbing moisture, leading to condensation within the living spaces of the home. Consequently, the HVAC system is compelled to operate with increased intensity to mitigate humidity levels and regulate indoor temperatures.

It is recommended that the existing insulation be removed and replaced with new, high-quality insulation that is installed in accordance with industry standards throughout the attic to enhance energy efficiency and prevent moisture-related issues.

- **Insulation Replacement:** It is recommended to remove the old insulation in the attic and install new insulation to prevent moisture accumulation and enhance HVAC efficiency.

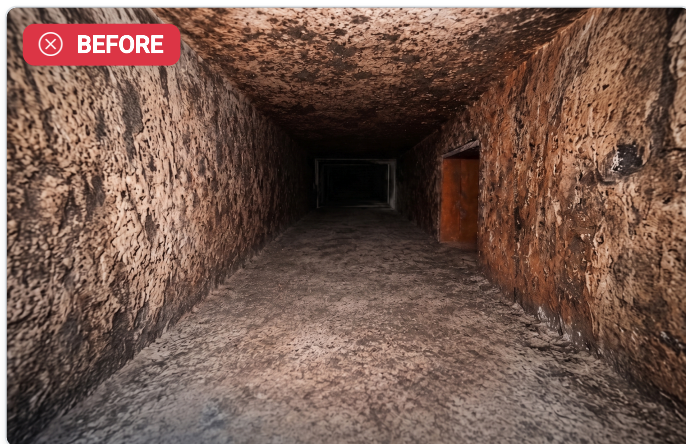
Process Description / Technical Summary

Remediation and Encapsulation of Internal Insulation A specialized process that complies with EPA guidelines for mold remediation in porous materials. It includes mechanical cleaning and subsequent encapsulation of fiberglass duct liners, plenums, and return boards using Fiberlock IAQ 8000. This solution encapsulates deteriorated surfaces to stabilize insulation and prevent fiber migration. Furthermore, it utilizes an EPA-registered fungistatic agent to actively inhibit microbial growth, restoring a healthy indoor environment.

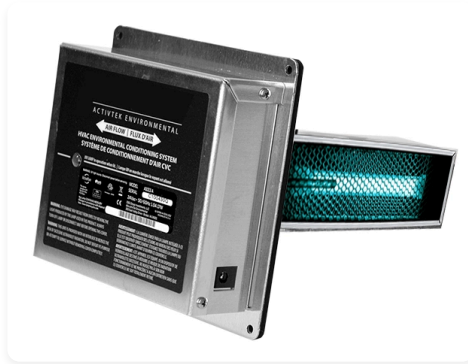
### Sani Duct Guardian

Installation of the Sani Air Duct Guardian within your HVAC system to actively neutralize airborne contaminants using a combination of UV-C light and advanced photohydrolysis technology. This proactive purification system seeks out and destroys pollutants at the source, ensuring cleaner, healthier air circulates throughout your property.

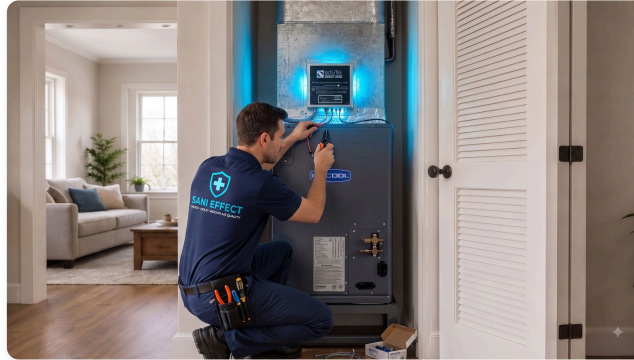
### Sani Guardian Equipment Installation Technician

Installation of advanced Sani Guardian air purification or environmental monitoring systems by a certified Sani Effect technician to ensure continuous, long-term indoor air quality management.
